Evaluation of Optical Materials Samples

FINAL REPORT

University of Dayton
Research Institute
Dayton, Ohio 45469

JULY 1988

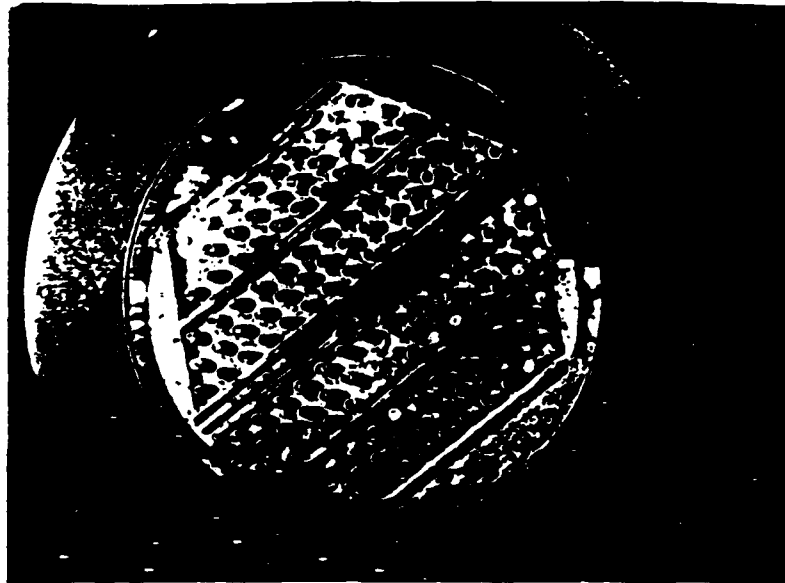
Figure 1. View of cooled mirror showing exposed faceplate support posts.

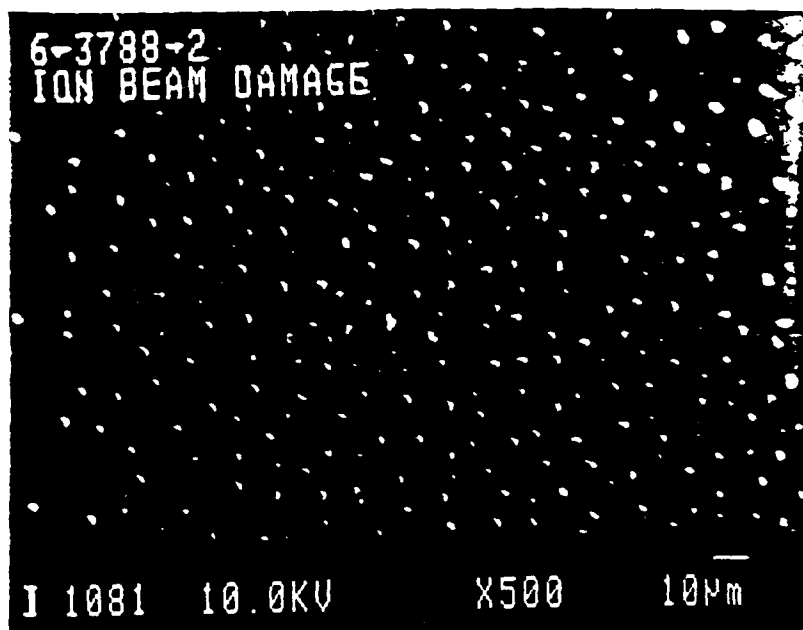
A focused argon ion beam was used to determine whether any localized damage would result from sputtering the ZnSe layer. Again, a region well away from any damage craters was selected. Figure 5 shows what appears to be small blisters on the order of a few microns in diameter after about 12.5 minutes of sputtering at a current density of approximately 1.5×10^{-4} amps/cm², which is two orders of magnitude lower than calculated for the electron beam current density in Figure 4 which was 4.6×10^{-2} amps/cm². Figure 6 shows the sputter crater after 16 minutes of sputtering. The central region of this crater resulted from both ion and electron beam damage. In a typical ion beam sputter crater one would anticipate seeing a shallow generally featureless crater. These results again suggest this specimen is a very poor conductor of heat. Whether this damage results from previous damage inflicted by laser irradiation or is characteristic of this particular ZnSe coating is not known. The major point of concern is that such catastrophic damage can be induced at relatively low power levels of e-beam and ion beam irradiation. Additional sputtering revealed that the sputtering effects seen in Figure 6 vanished as the ZnSe layer was penetrated. The ThF₄ underlayer appeared flat and features within the ion beam perimeter.

Figure 5. Damage blisters which resulted from 12.5 minutes ion beam sputtering at 2 KeV. The ion beam current density was at least 2 orders of magnitude lower than the electron beam current density used in Figure 2.

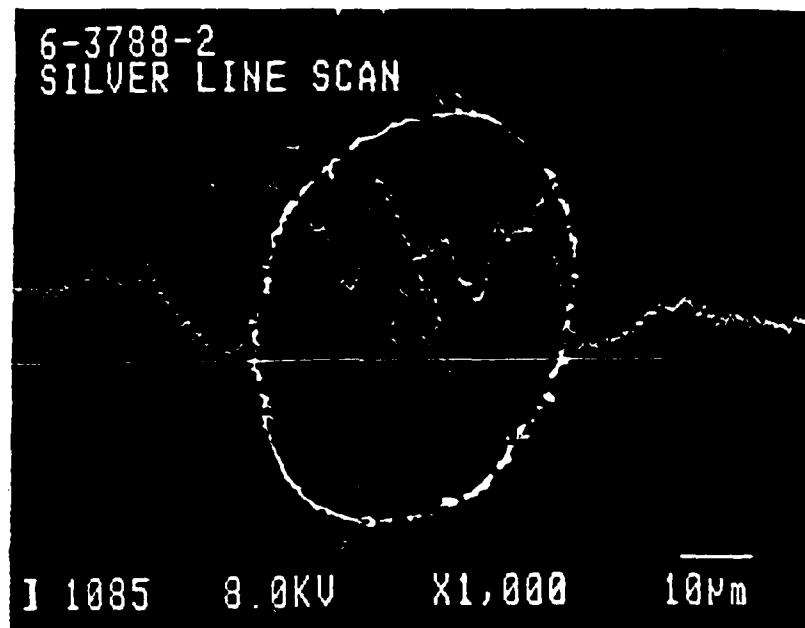
Crater #2 was ion sputtered for a sufficient period of time to remove the surrounding ZnSe layer. Figure 8 shows crater #2 with the ZnSe layer etched away. Auger line scan for silver is superimposed on this photograph along with the actual line which was scanned. It is evident that a ring containing a significant amount of silver forms the crater rim. Larger concentrations of silver are apparent within the crater than immediately outside. There is a halo region surrounding the crater edge about 10 microns wide where the silver level reaches a minimum. Beyond this the silver concentration again increases. We suggest that this could result from debris expelled from the crater during catastrophic failure. It is almost certainly not an ion beam effect. Auger spectra were acquired in regions (from Figure 8) to the left of the halo (Figure 9), on the rim of the crater (Figure 10), and in the crater below the center pit (Figure 11). Table 1 shows the elemental concentrations from these three regions in atomic percents.

Figure 8. Crater #2 after the ZnSe layer had been sputtered away. A silver Auger line scan is superimposed along with the actual line which was scanned. Silver is present in all but the 10 micron halo region immediately adjoining the crater rim.

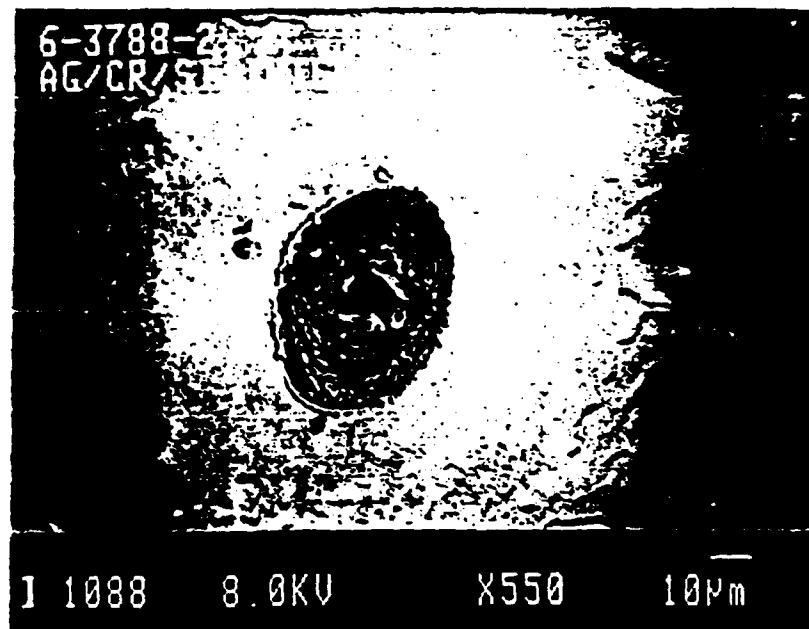
Figure 14 shows crater #2 at the silver/chromium/silicon interface. Figure 15 is an Auger spectrum taken inside the crater rim. Silver,

Figure 14. A secondary electron image of crater #2 at the silver/chromium/silicon interface. There appears to be some blistering at the silver/thorium fluoride interface along the right edge and at the bottom of this micrograph.

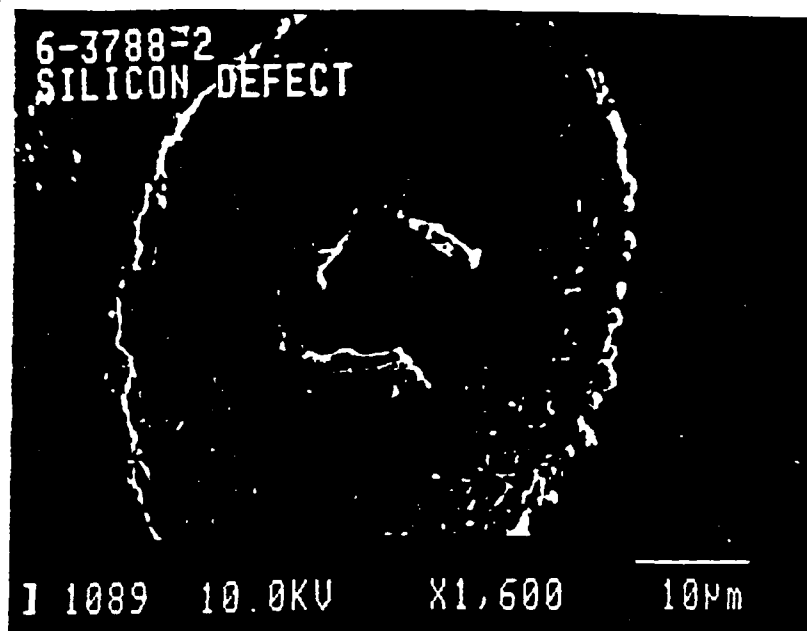
Figure 17 shows crater #2 with most of silver and chromium sputtered away. A feature in the center of this crater which could be a defect in the silicon is apparent. Further, roughness in the area within the crater rim suggests that the silicon substrate may have undergone localized melting during catastrophic failure.

Figure 17. Silicon substrate at the crater #2 site. A pit is observed at the center of this crater. If this defect was present before testing, it could have been responsible for the failure of this film at this site.

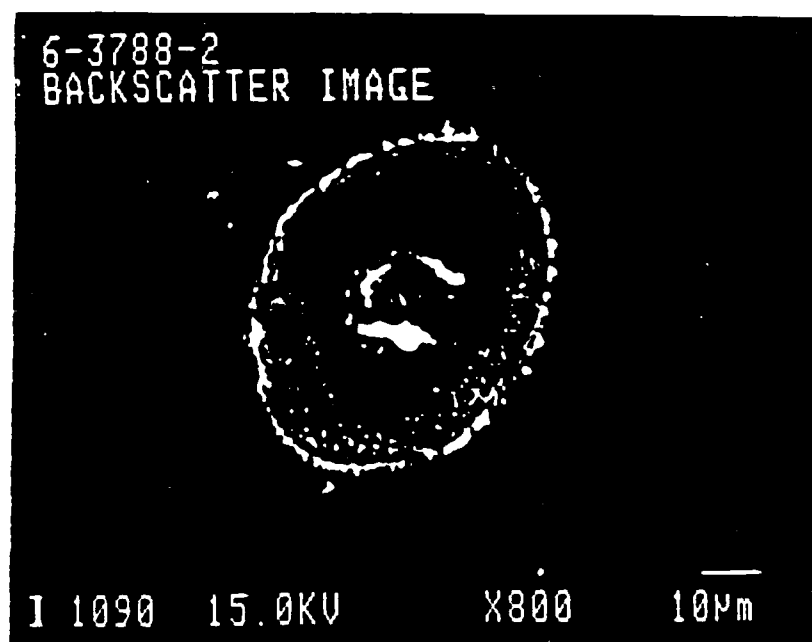
A composition backscatter electron image from crater #2 is shown in Figure 18. Heavier elements with larger backscatter coefficients appear bright whereas lighter elements appear darker in color. Auger spectra confirm that the light areas are rich in silver and chromium whereas the gray region is pure silicon.

Figure 18. Compositional backscatter electron image of crater #2 after sputtering. The bright regions indicate the presence of heavy elements (silver and chromium) whereas the neutral gray region indicates the silicon substrates.

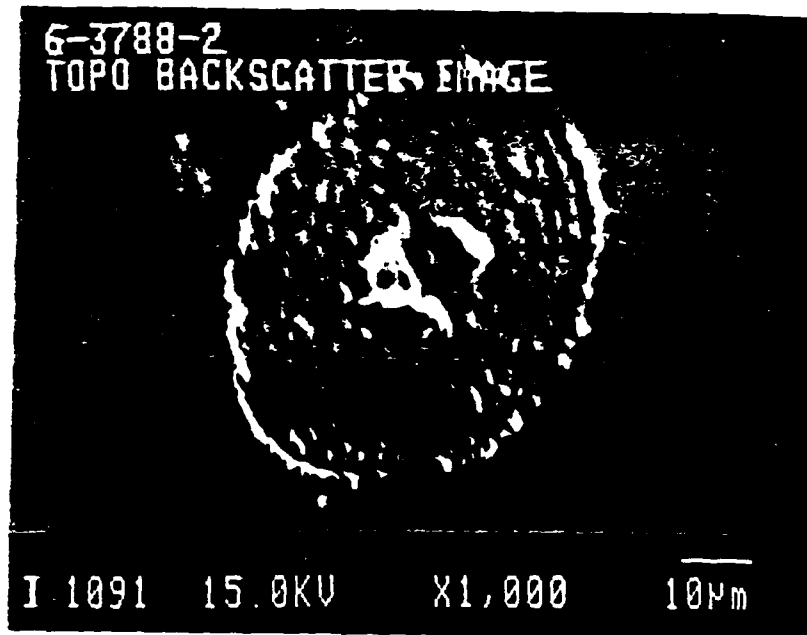
A topographical backscatter image of crater #2 is shown in Figure 19. The center defect, the silver rich crater rim, and the rough surface within the crater are clearly visible. The features at the upper left of the crater could be from expelled debris or possibly other subsurface defects. Defects in the silicon substrate such as pits or subsurface voids could well serve as failure nucleation sites because of their inability to dissipate heat evenly. Cratering could then occur expelling debris from the

Figure 19. A topographical backscatter electron image of crater #2 after sputtering. This failure has changed the surface topography. It is not unreasonable to suspect that the failure originated at the central defect leading to subsequent localized melting of the silicon substrate and the optical coating overlayers.

inner most layers which would end up inverted within the crater debris near the rim. This cratering mode of failure would explain the presence of silver in the crater debris spectrum shown in Figure 7. Depending on temperatures during failure, localized melting of the silicon substrate could occur leaving an uneven surface after resolidification.

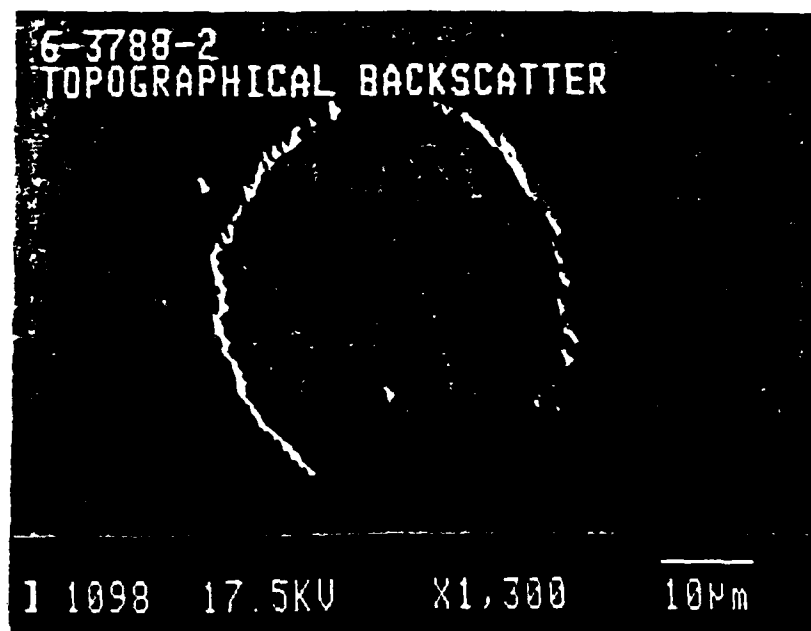
Figure 22. Topographical backscatter image of crater #3 after sputtering. The crater rim and the textured region within the crater are clearly visible.
